# Laconic Industries

## Inspection Report

**742 Evergreen Terrace**

Inspected on Sat, Jun 14 2014 at 1:00 PM

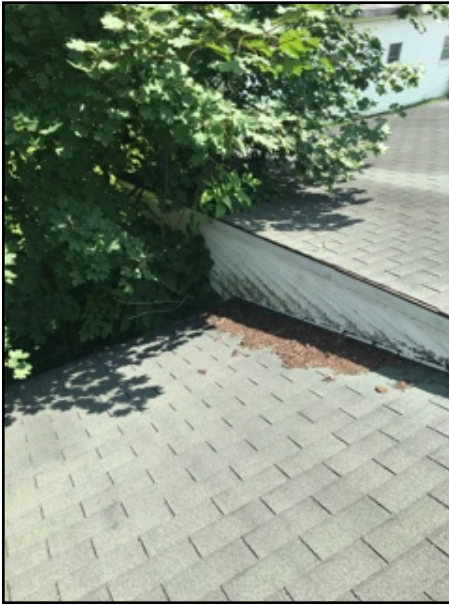
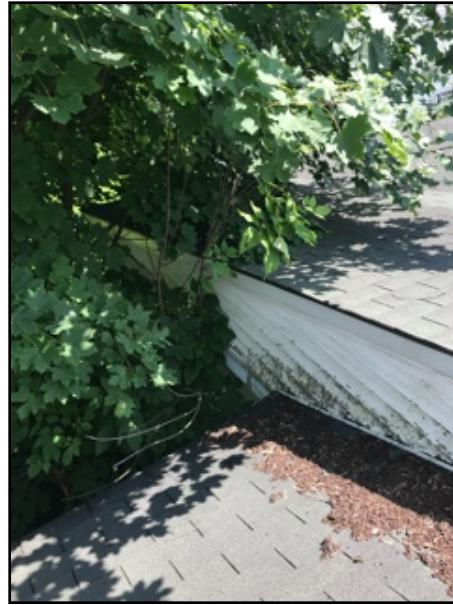
Roof had dormers, valleys or other features that may be prone to leaking. Although no active leaking was found on the day of the inspection, areas may manifest different characteristics based on season or weather patterns. Recommend monitoring all roof areas carefully and address any water intrusion immediately to prevent issues from developing.

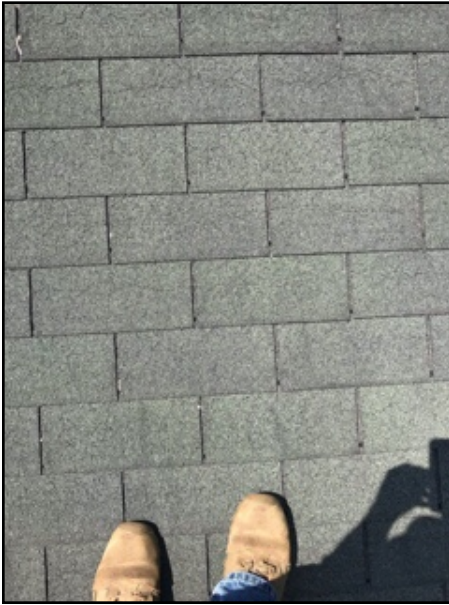
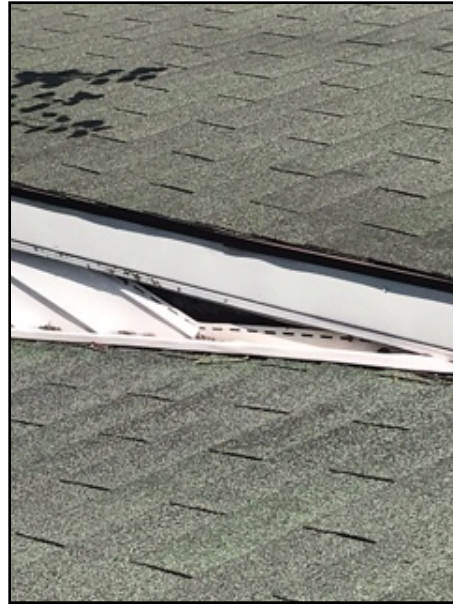
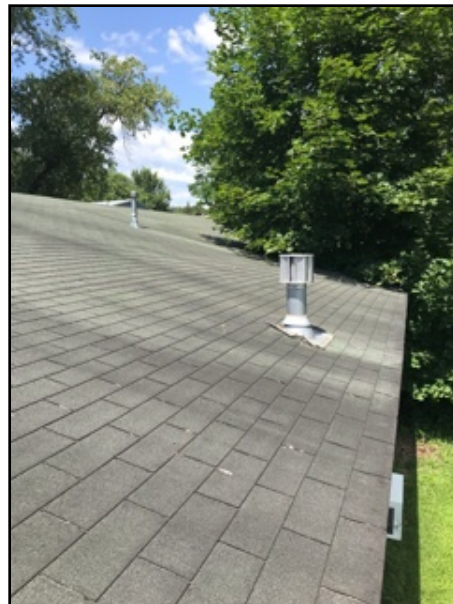
**Comment 13:**  
3 Tab shingles were noted : Roof was functional but near the end of its expected useful life span.

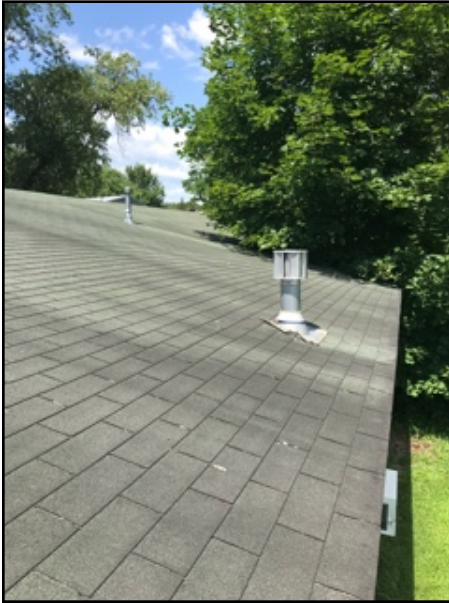
Figure 16-1

Comment 16:  
Metal roof vents were noted.

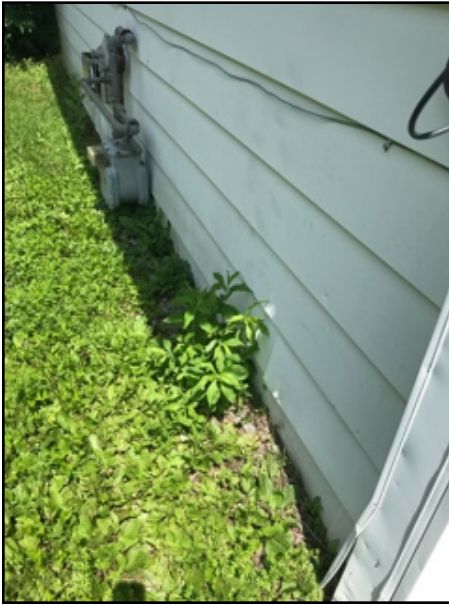
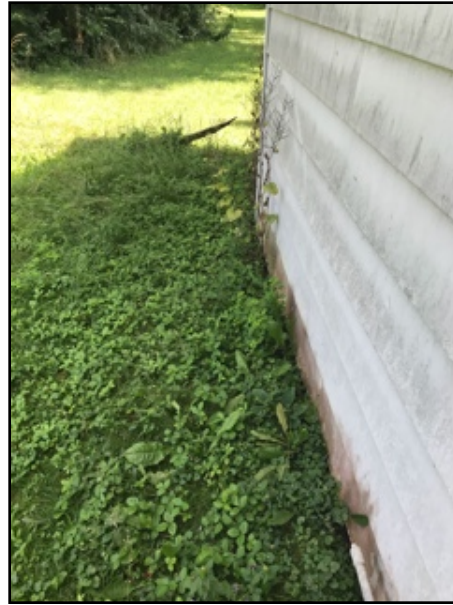
Comment 17:  
Siding to Soil contact or proximity. This may provide entrance of moisture or insects to siding. Recommend grading soil so there is at least 6" of space (where practical) between the siding and the soil below and checking for any damaged trim and siding materials.

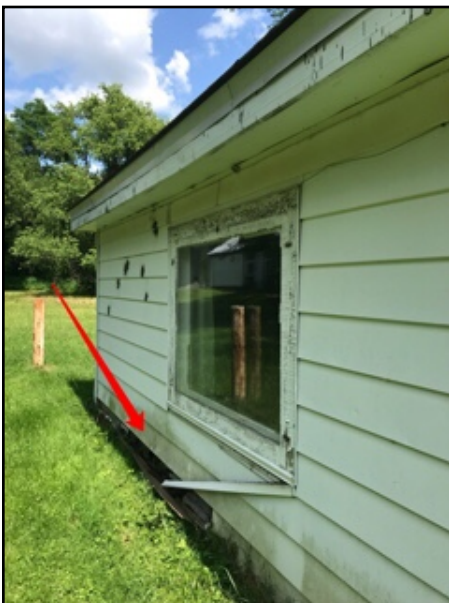
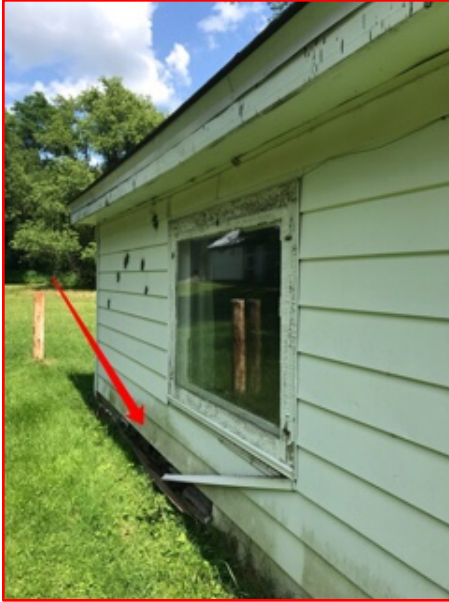
AREA OF POSSIBLE MAJOR CONCERN - Moisture damage, wood rot, observed. Recommend review for repair by a contractor specific to this area pf expertise.

- 1) Open areas or damage was found. Repair or replace as needed.
- 2) AREA OF POSSIBLE MAJOR CONCERN - Moisture damage, wood rot, observed. Recommend review for repair by a contractor specific to this area pf expertise.

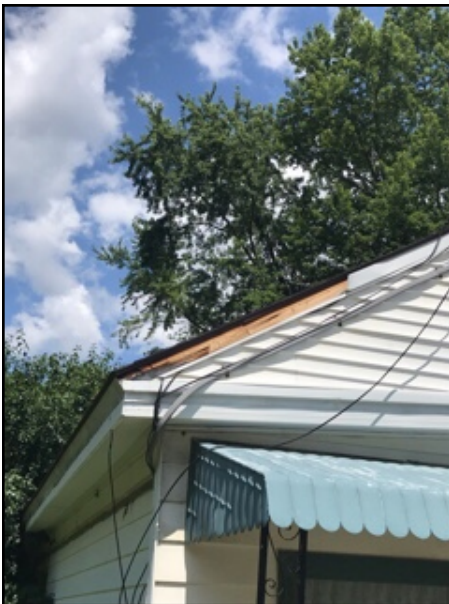
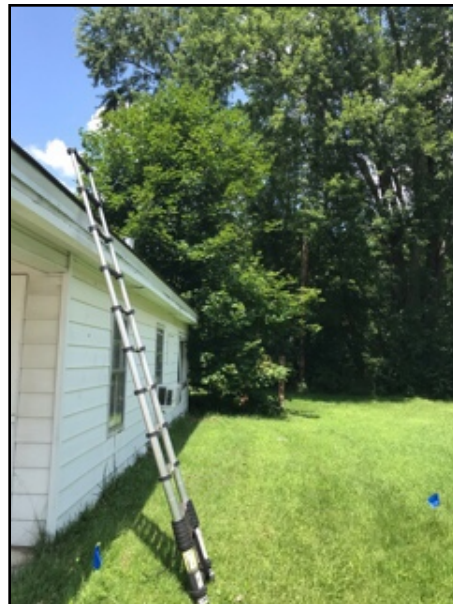
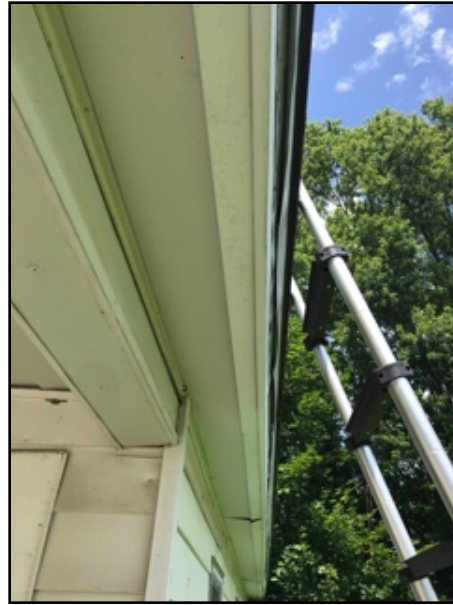
Penetrations , cracks,or holes were found. Address as needed.

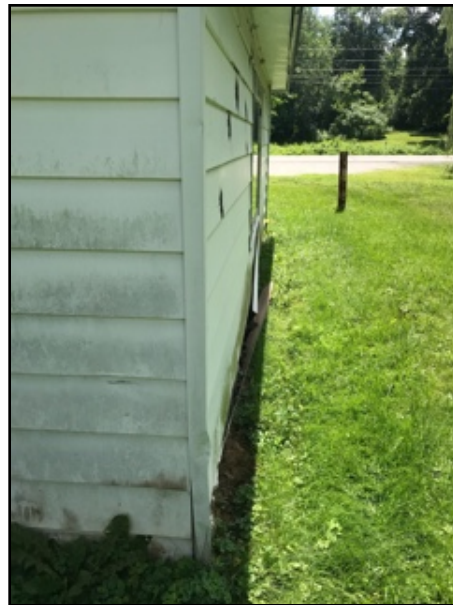
Figure 22-2

Grading around the structure appeared to encourage water to flow towards house and collect.

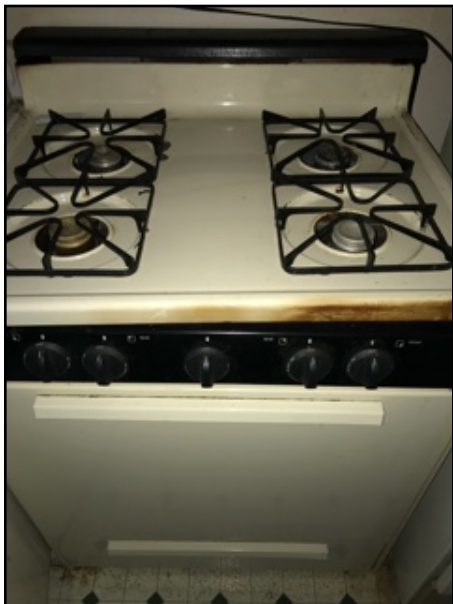
Appliances were operational the day of the inspection.

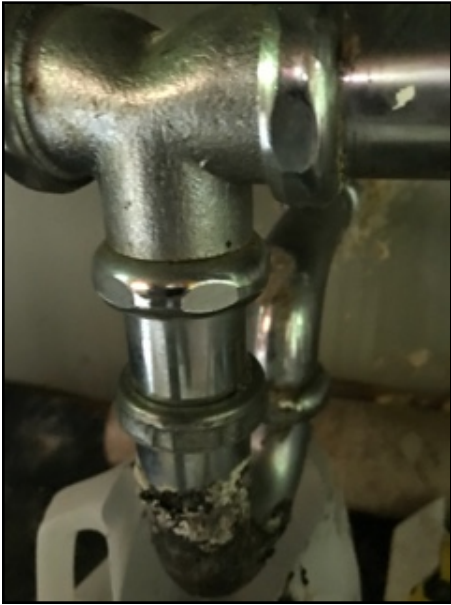
Figure 30-1

Chrome drains were noted. Chrome drains may fail at any time without notice. Recommend replacement prior to issues.

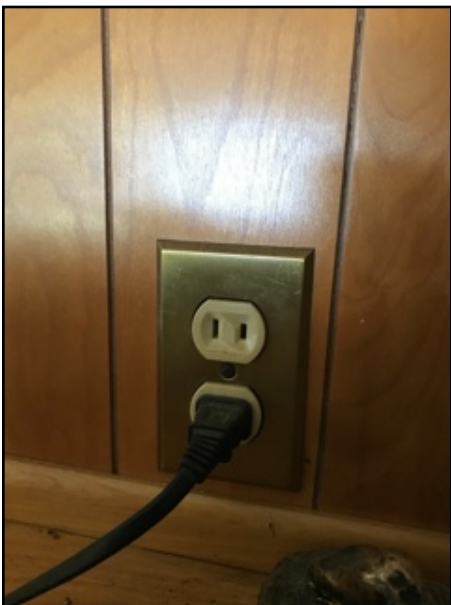
Figure 32-1

Non GFCI outlets were found. Recommend installation of GFCI protected outlets in any location where water and electrical may contact to protect occupants.

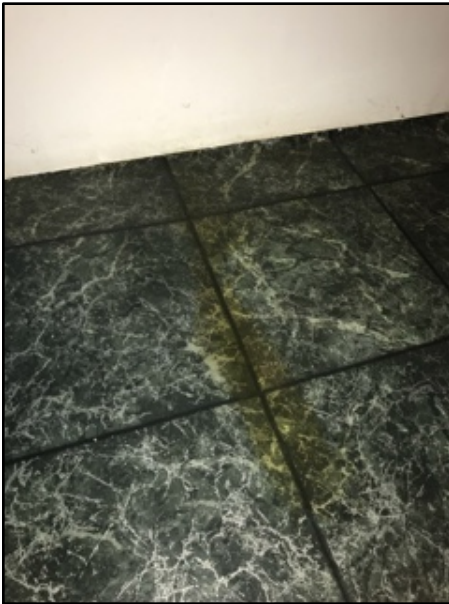
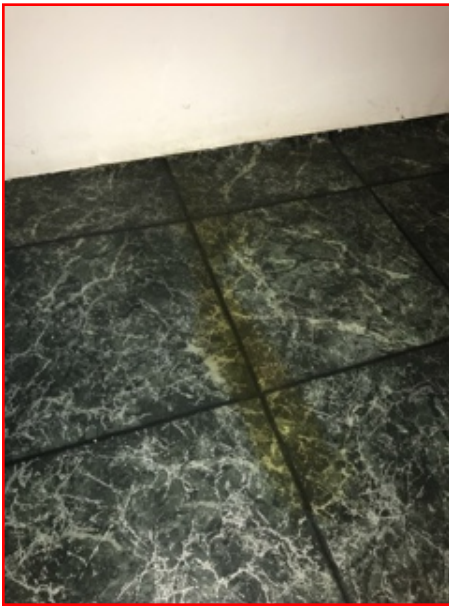
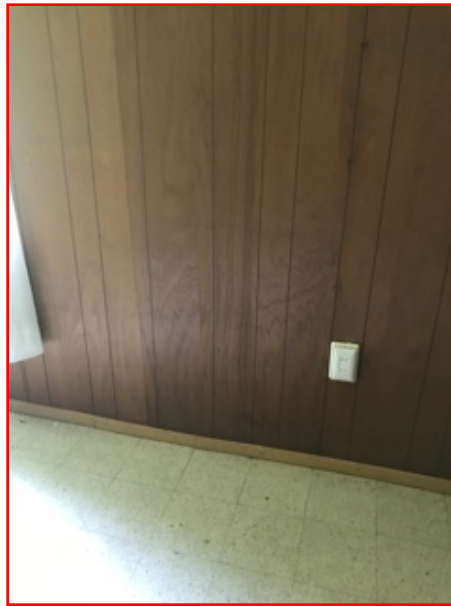
Evidence of settling or structural movement was observed.

3) Evidence of settling or structural movement was observed.

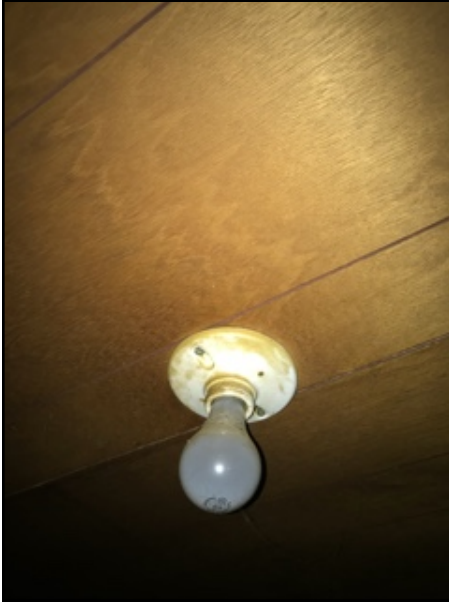
Figure 37-1

Exposed bulbs were found in the closets. Bulbs should be in an enclosed globe to protect occupants from breakage.

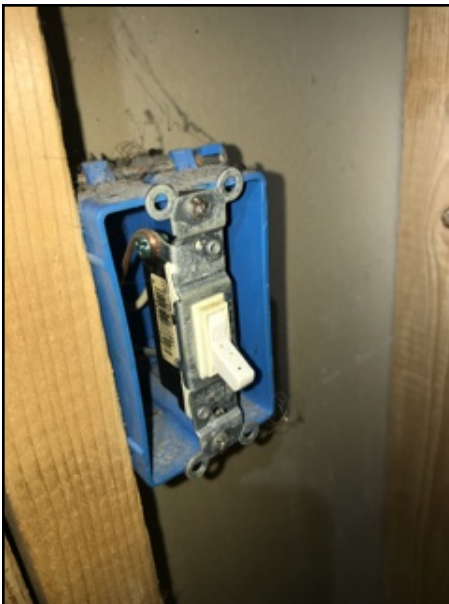
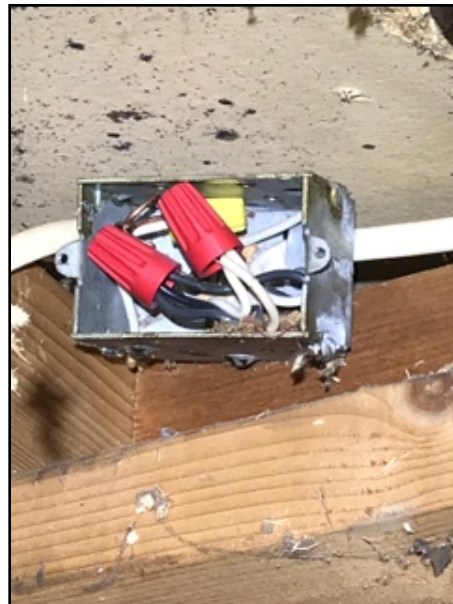
Cover plates were missing.

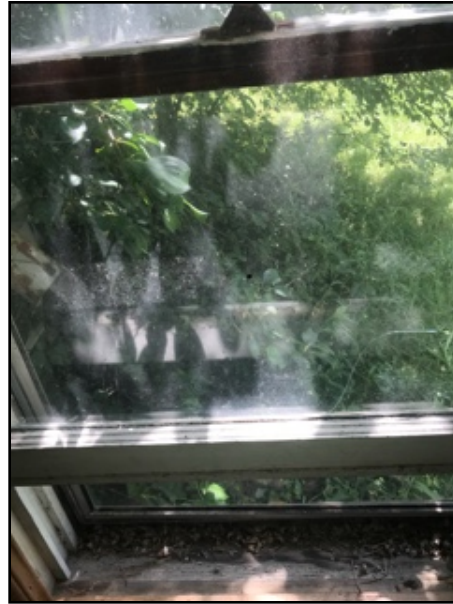
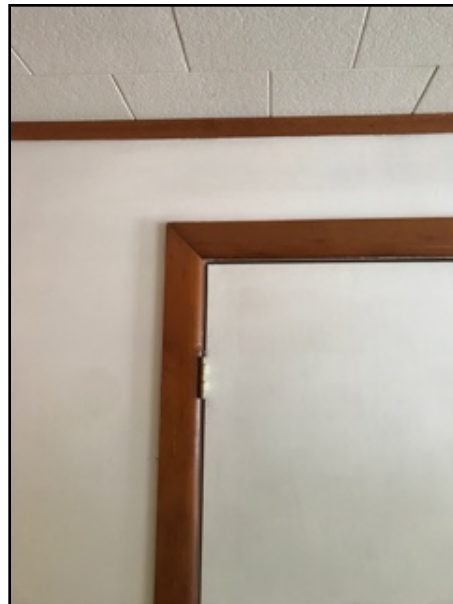
**Comment 40:**  
Accessible and inspected windows and doors were operating normally.

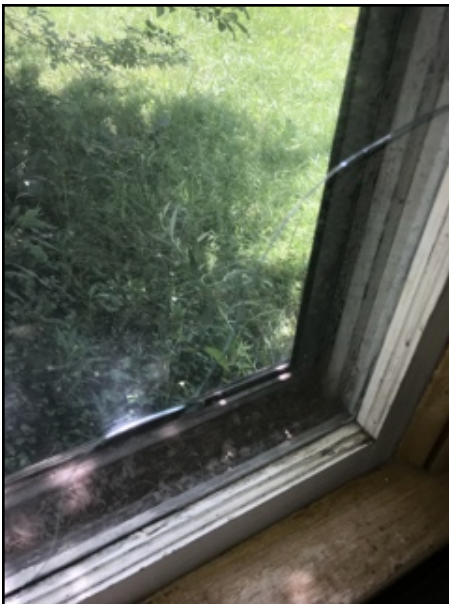
Figure 41-1

Comment 41:  
Some window were damaged.

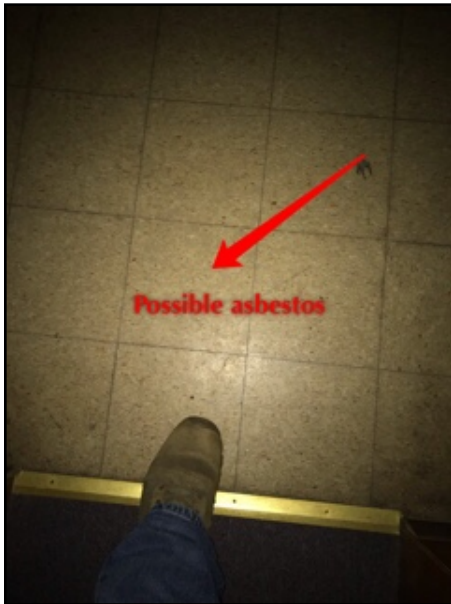
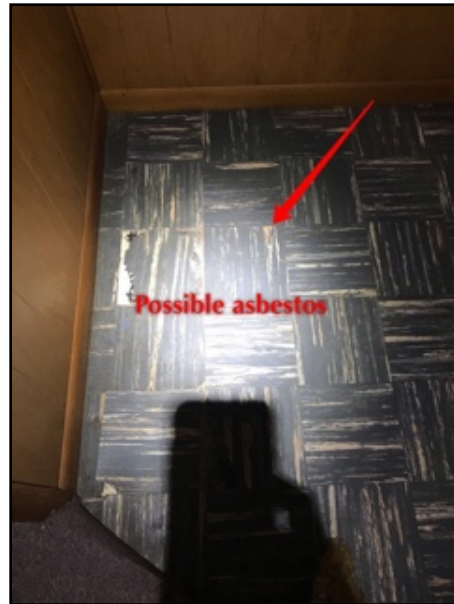
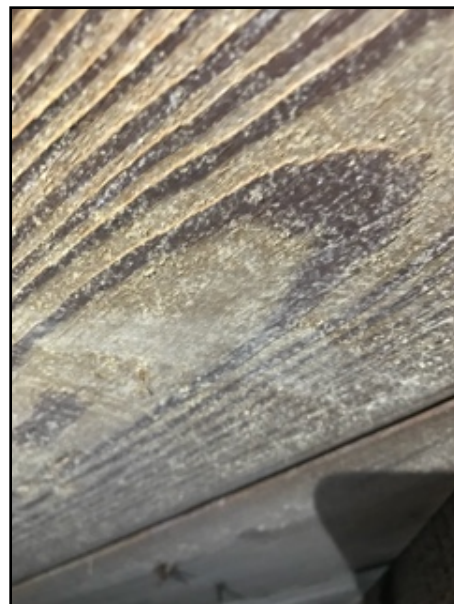
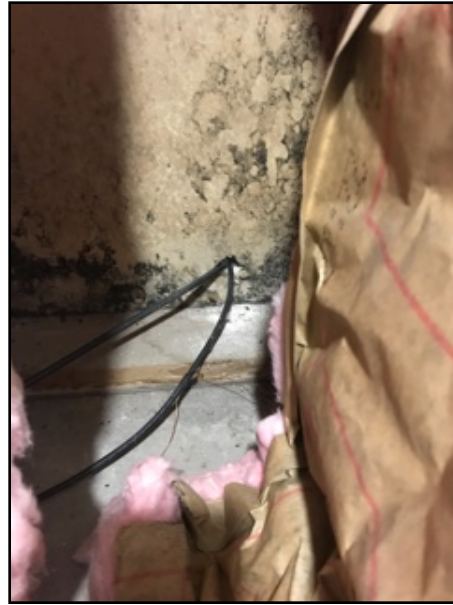
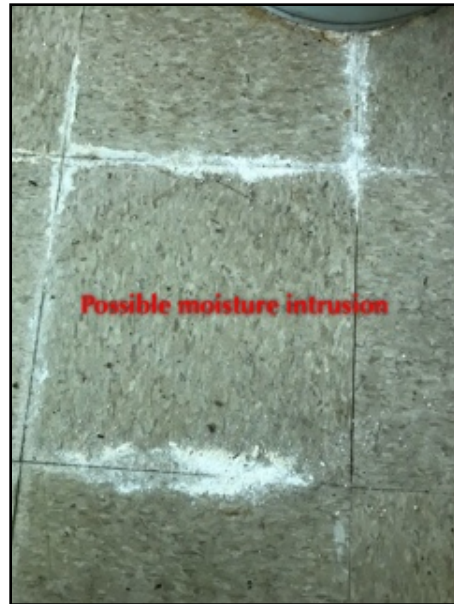
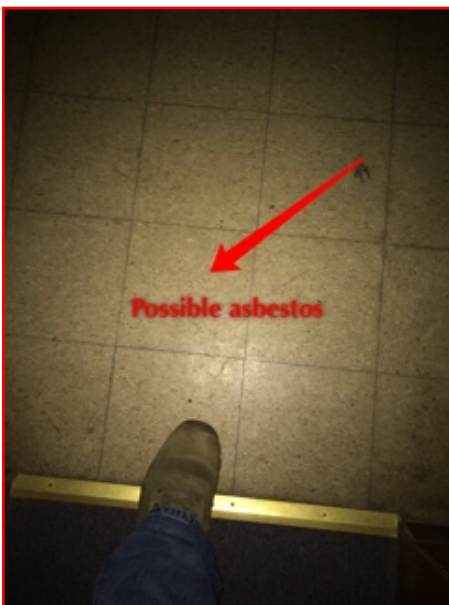
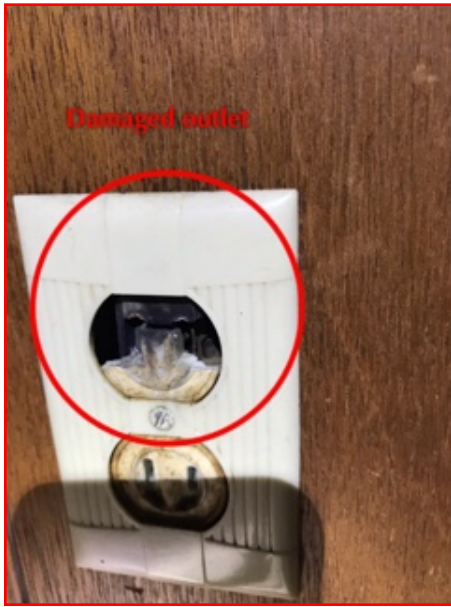
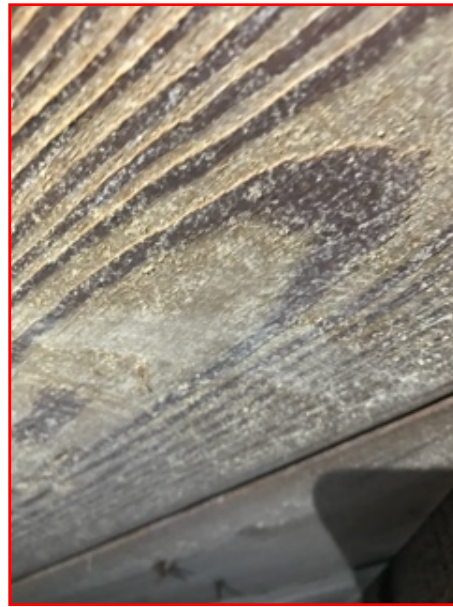
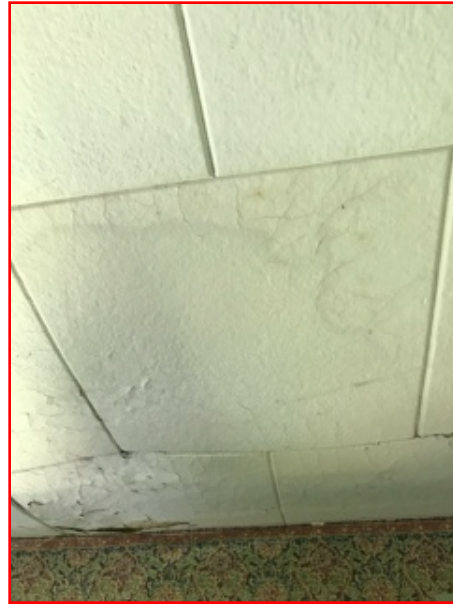
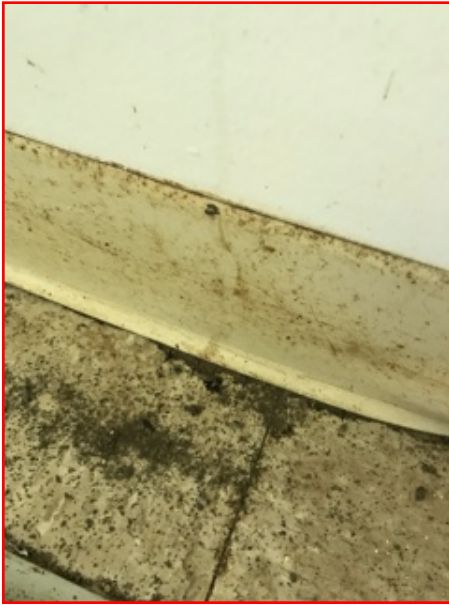
AREAS OF POSSIBLE MAJOR CONCERN WERE FOUND.

4) AREAS OF POSSIBLE MAJOR CONCERN WERE FOUND.

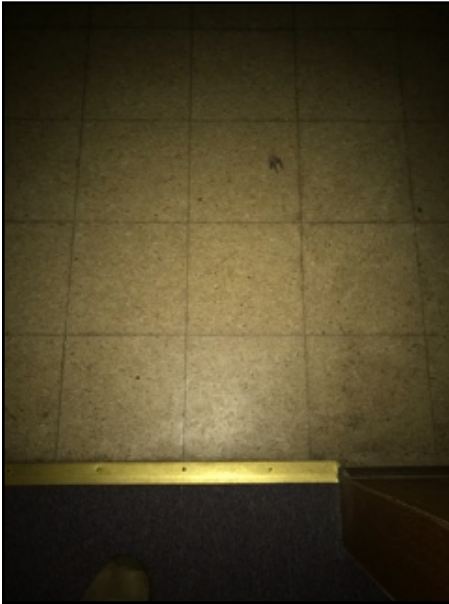
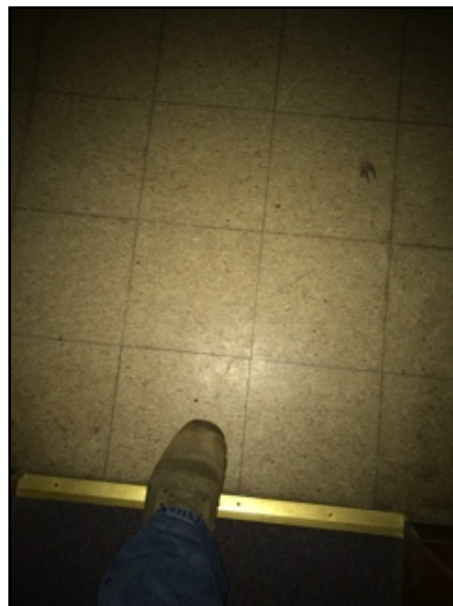
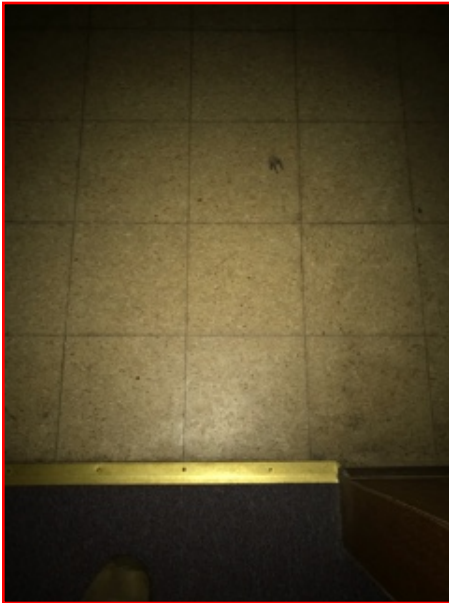
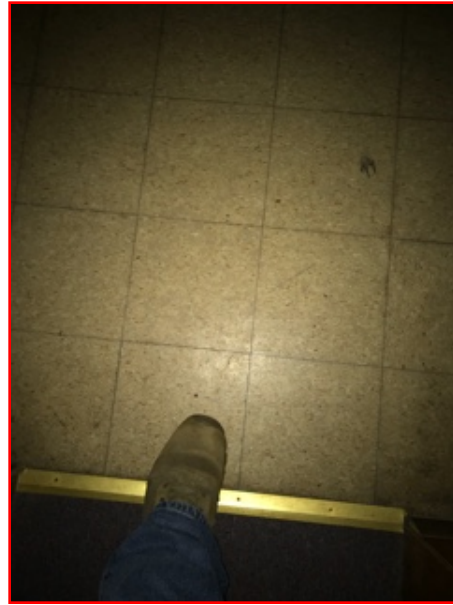
Possible asbestos found in the flooring of the home. Component may contain asbestos. Asbestos exposure has been linked to health problems and may merit further investigation. Positive confirmation can only be done by a licensed asbestos professional. Consultation with an asbestos professional may be desired prior to commitment.

5) Possible asbestos found in the flooring of the home. Component may contain asbestos. Asbestos exposure has been linked to health problems and may merit further investigation. Positive confirmation can only be done by a licensed asbestos professional. Consultation with an asbestos professional may be desired prior to commitment.

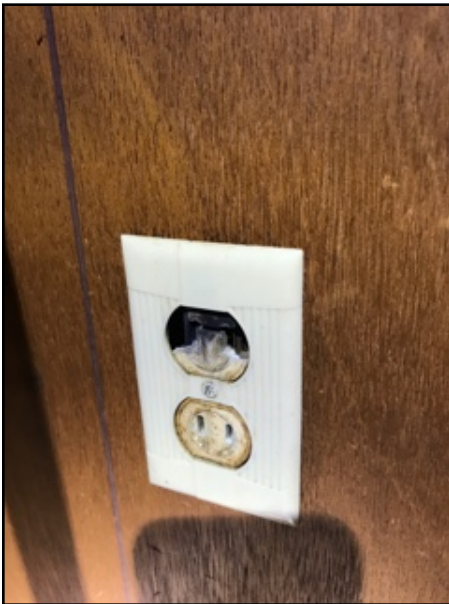
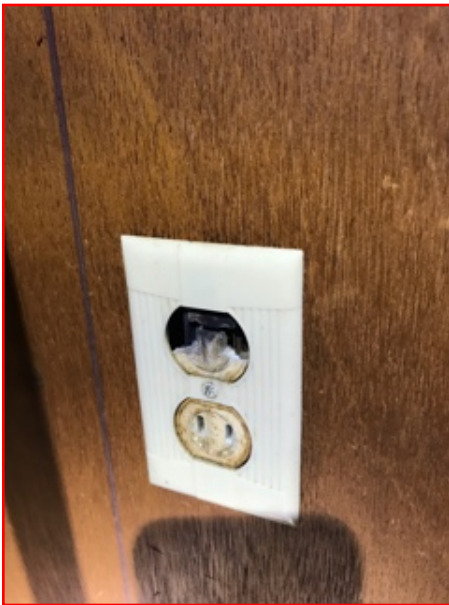
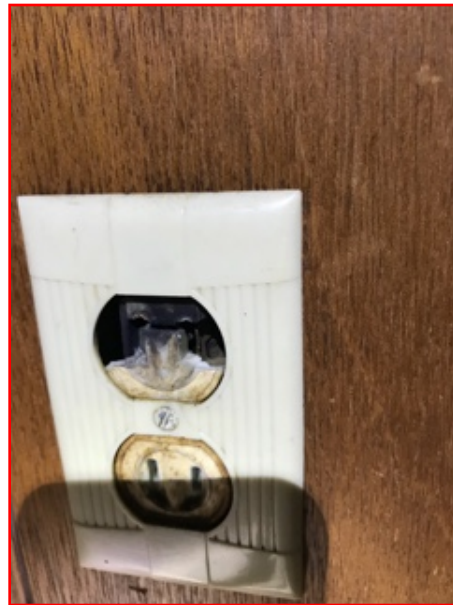
Comment 44:  
Some outlets appeared damaged or broken.

6) Some outlets appeared damaged or broken.

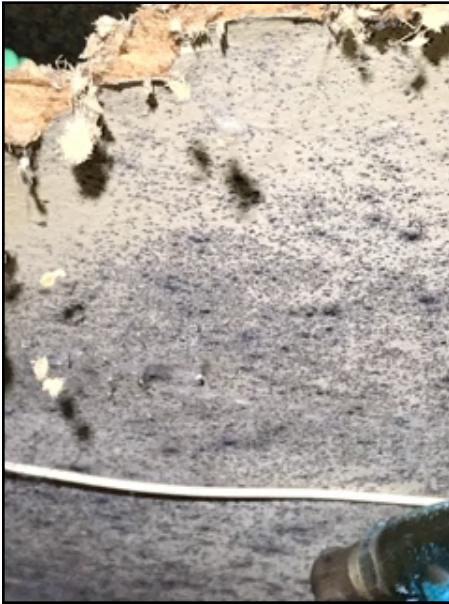
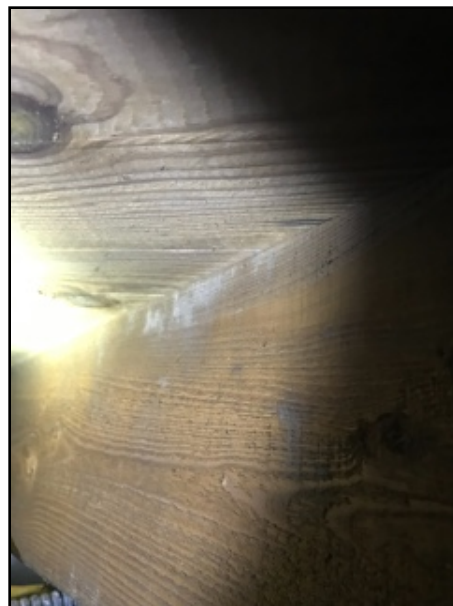
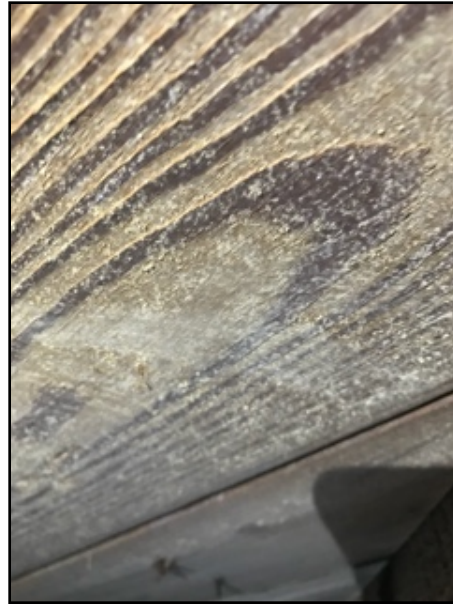
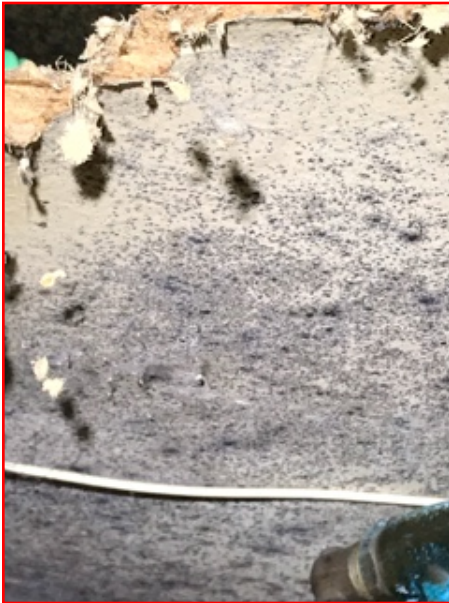
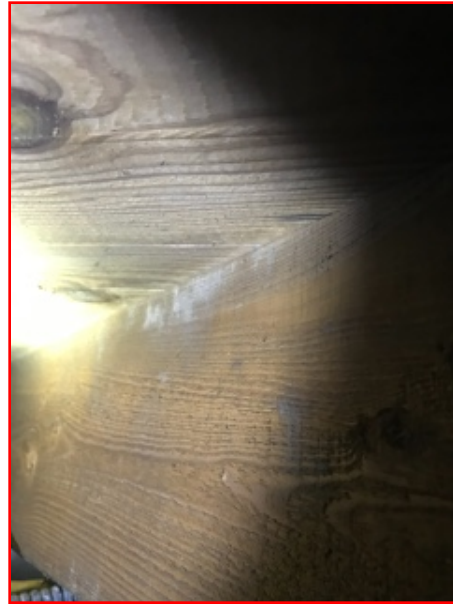
A suspicious discoloration or possible microbial growth was noted. Discoloration may indicate a larger issue adversely affecting the structure. Recommend a qualified specialist be contacted to evaluate the area and recommend corrective course. Additional areas of the house may require assessment at the discretion of the specialist.

8) A suspicious discoloration or possible microbial growth was noted. Discoloration may indicate a larger issue adversely affecting the structure. Recommend a qualified specialist be contacted to evaluate the area and recommend corrective course. Additional areas of the house may require assessment at the discretion of the specialist.

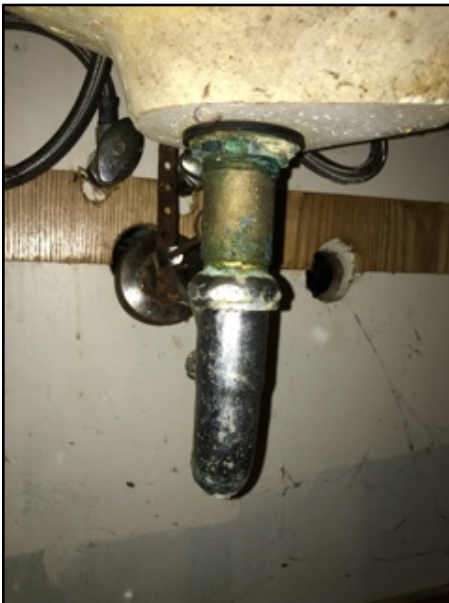
Figure 47-1

Chrome drains were noted. Chrome drains may fail at any time without notice. Recommend replacement prior to issues.

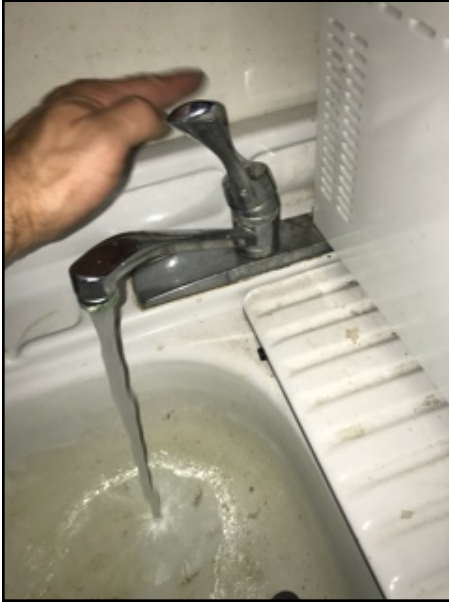
Figure 48-1

Functional flow: Water pressure was checked by opening multiple fixtures at the same time. No noticeable drop was found.

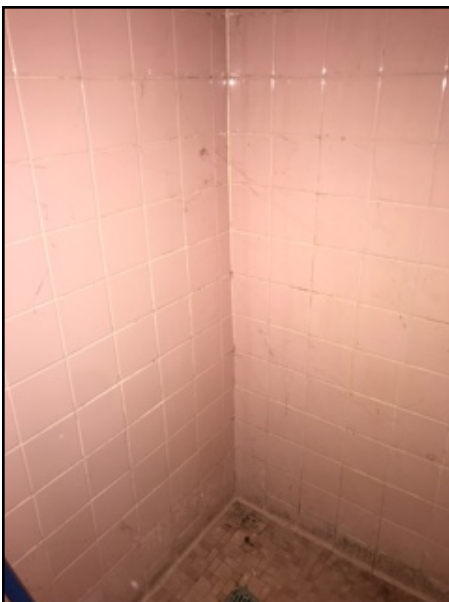
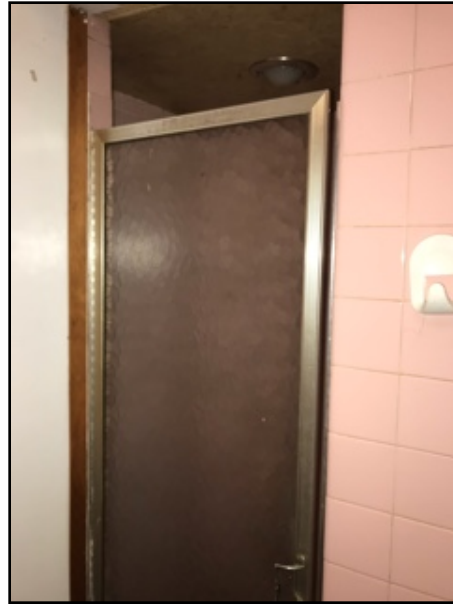
Caulk or grouting was missing or required. Recommend adding of caulk, grout or of appropriate sealant.

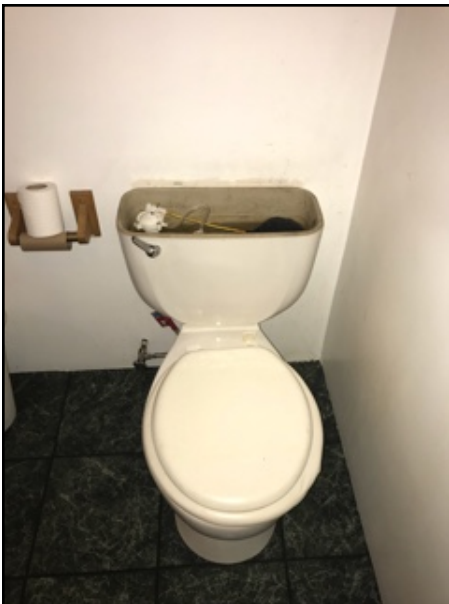
Figure 50-1

Comment 50:  
Toilet reservoir lid was missing.

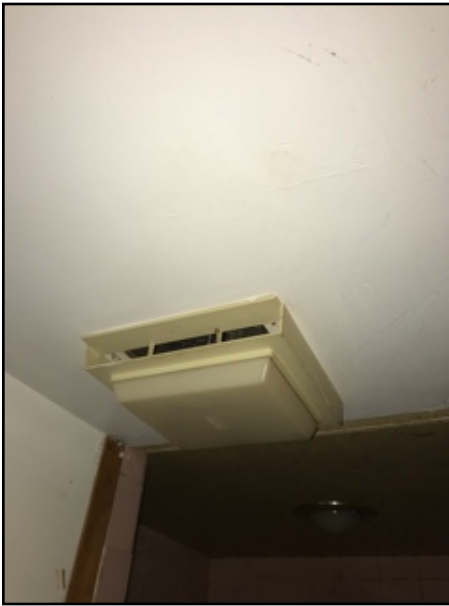
Figure 53-1

Exhaust fan duct appears to terminate in attic. Have duct routed to exterior to minimize moisture and possible development of mold.

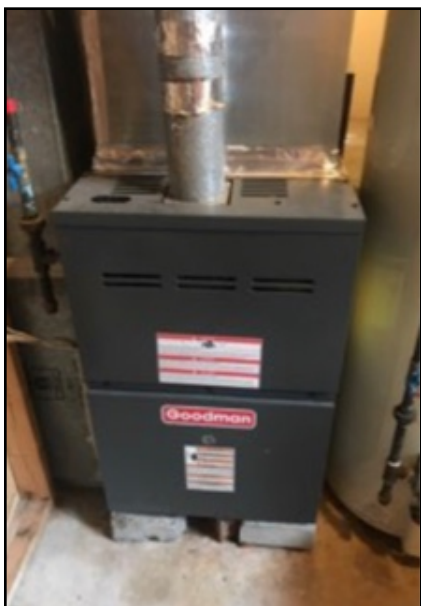
Due to the limitations of a home inspection it is recommended that a qualified specialist can fully inspect and test the internal elements of the heating and cooling system, and a regular maintenance program be instituted immediately. An HVAC company's inspection will likely be more thorough than a home inspection and may reveal other issues that were not manifest during the inspection.

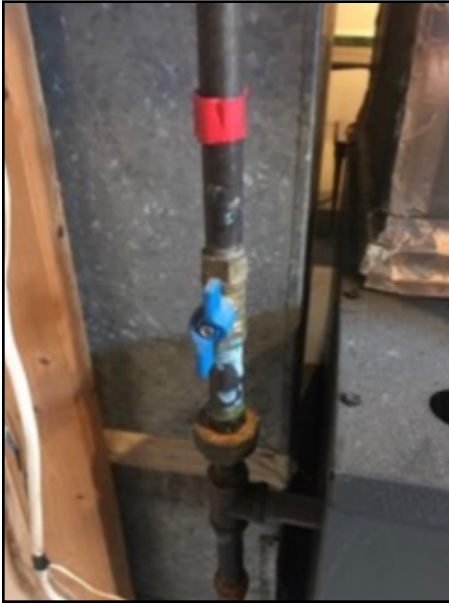
Figure 61-1

A gas shut off was noted at the unit.

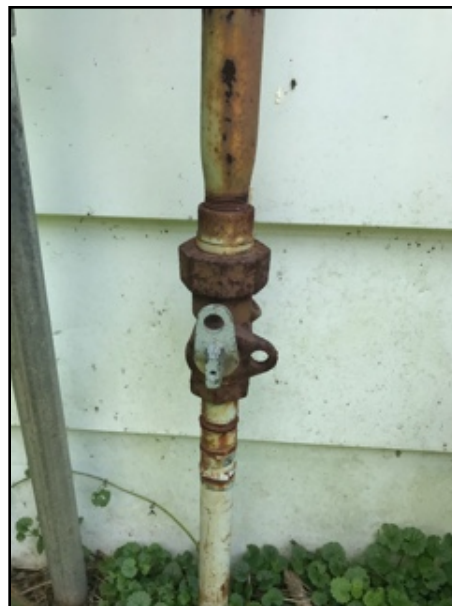
Figure 62-2

Gas meter was at the left of the building.

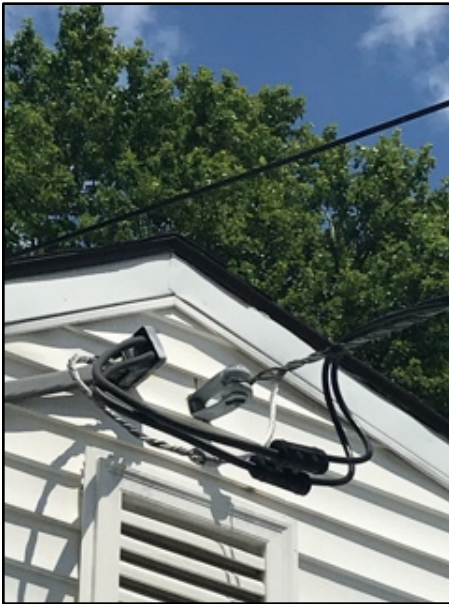
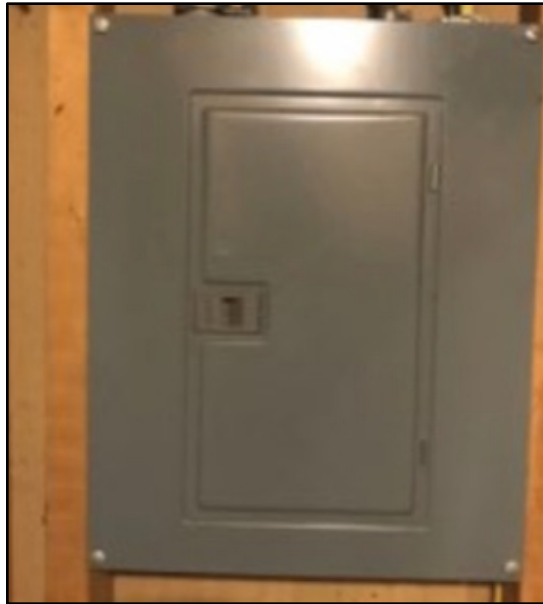
Comment 65:  
Over head service entrances was noted .

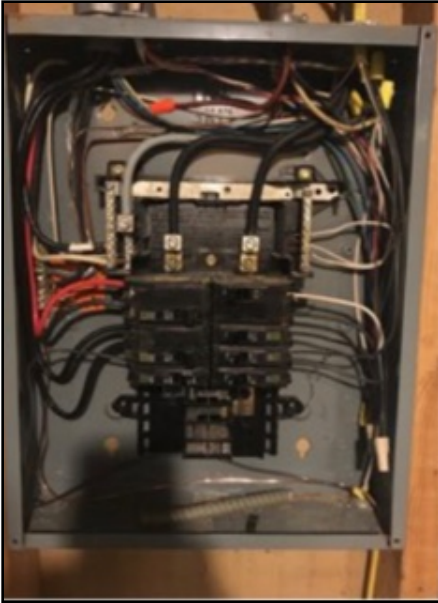
Figure 67-1

No single main breaker. Split bus design was found.

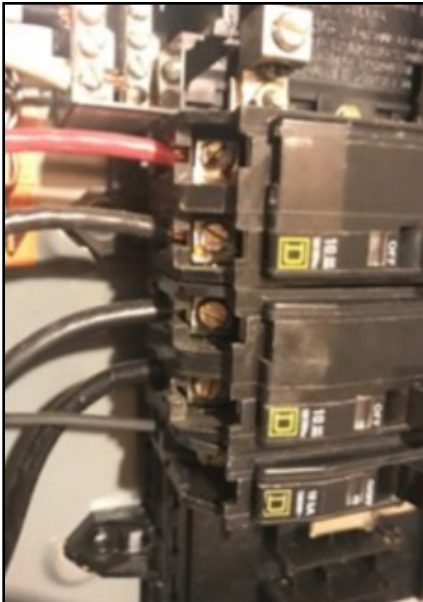
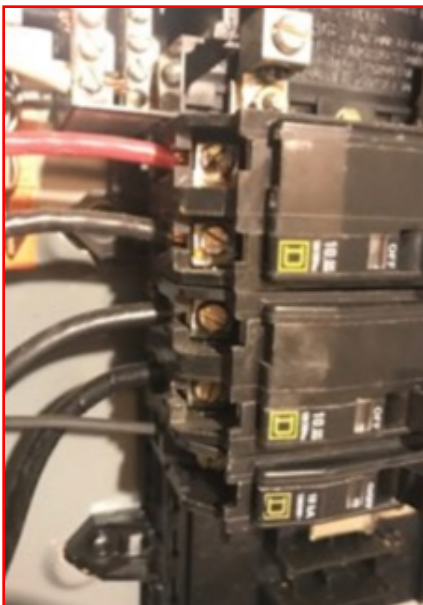
Rust was noted. Corrosion was found on the breakers. Breakers may not be functioning as designed due to rust.

12) Rust was noted. Corrosion was found on the breakers. Breakers may not be functioning as designed due to rust.

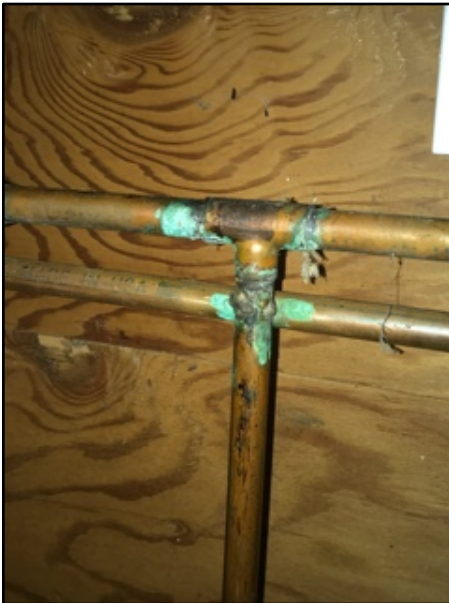
Figure 71-1

Areas of leaking or corrosion were found. Repair or replace as needed.

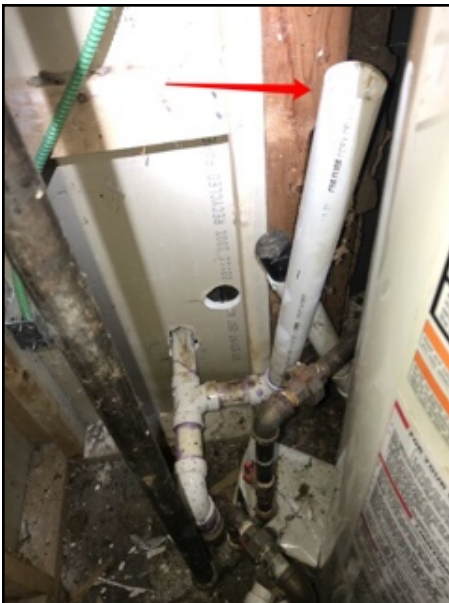
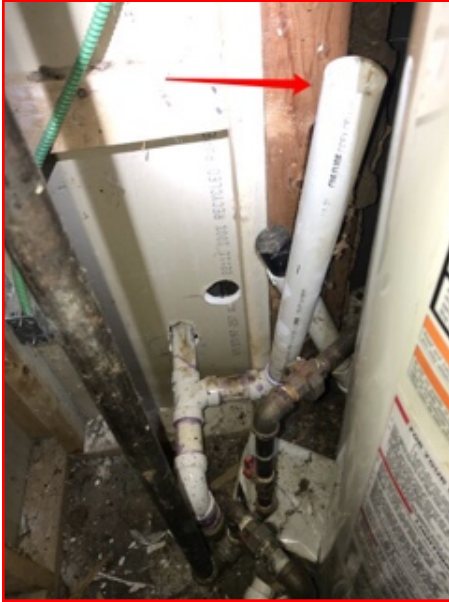
Plumbing vent pipes terminate in the utility area. This can lead to moisture and sewer gas exhausting into the building.

13) Plumbing vent pipes terminate in the utility area. This can lead to moisture and sewer gas exhausting into the building.

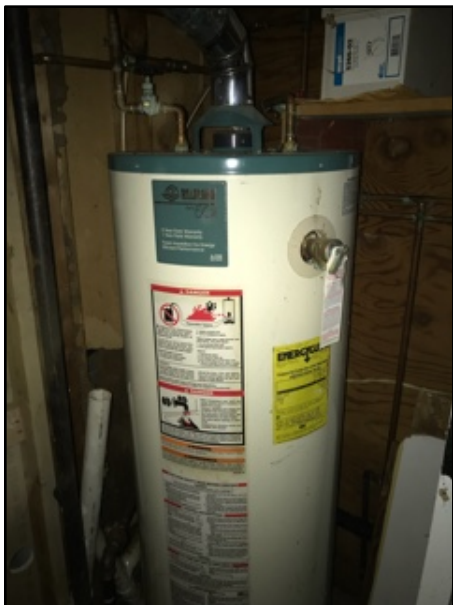
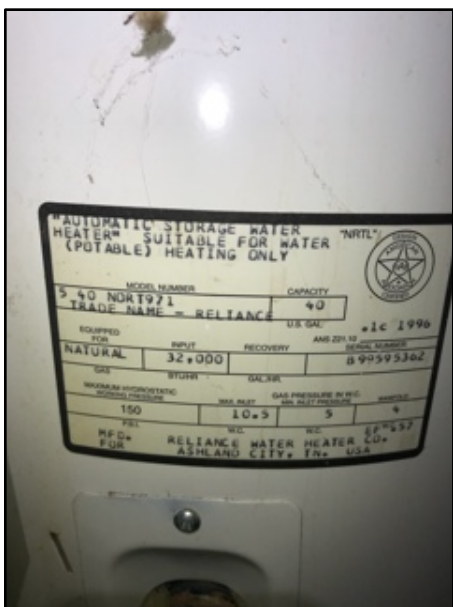
A gas hot water heater was in use .

Unit appeared older. Average lifespan of water heaters is approximately 10 years. Unit may require replacement at any time. Recommend budgeting for replacement in the near future.

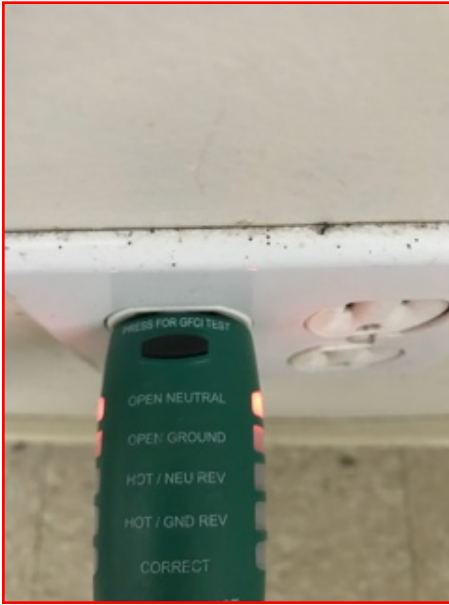
Figure 45-1

Comment 45:  
Outlets tested as having open neutrals, grounds or other faults.

7) Outlets tested as having open neutrals, grounds or other faults.
