# Laconic Industries

## Inspection Report

**742 Evergreen Terrace**

Inspected on Sat, Jun 14 2014 at 1:00 PM

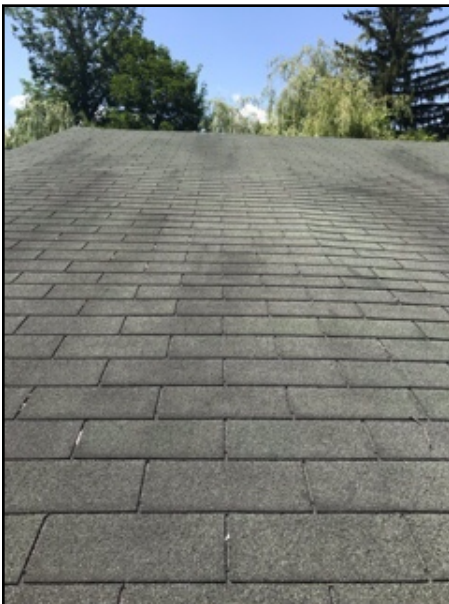
Figure 13-3

**Comment 13:**  
3 Tab shingles were noted : Roof was functional but near the end of its expected useful life span.

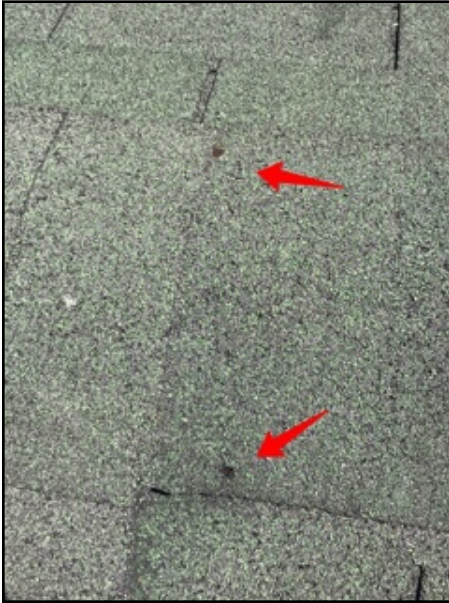
Figure 15-1

Comment 15:  
Exposed nails.

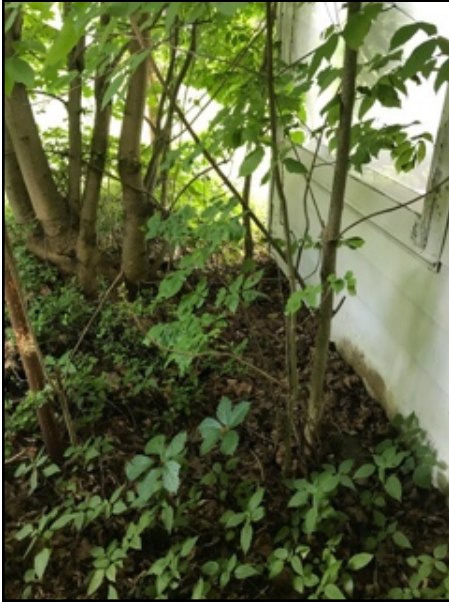
Figure 21-1

Close growing vegetation was in contact with the building and could be damaging to the structure .

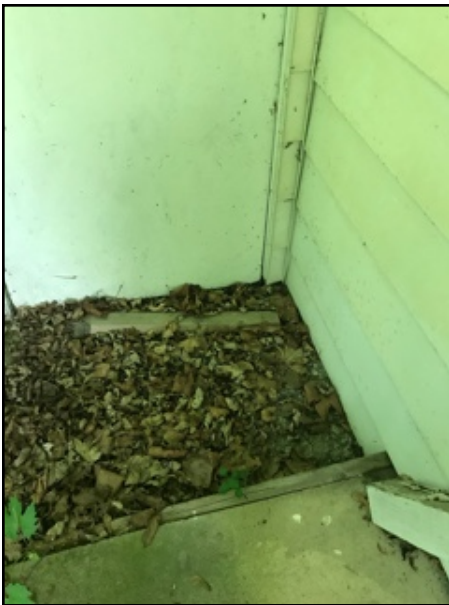
Figure 22-1

Grading around the structure appeared to encourage water to flow towards house and collect.

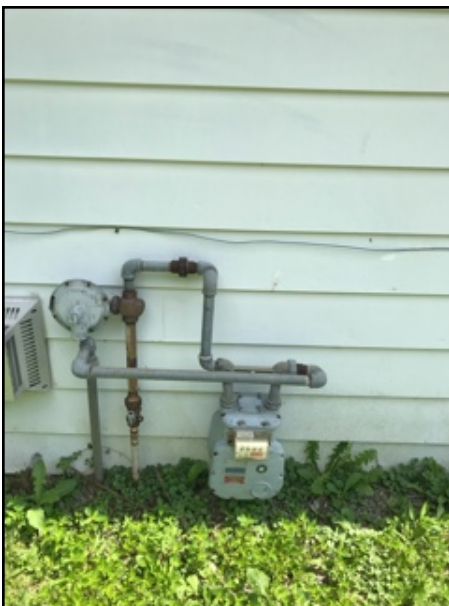
Figure 62-1

Gas meter was at the left of the building.

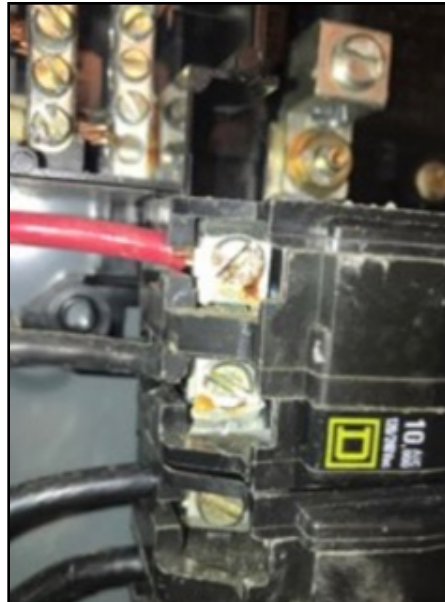
Figure 68-2

Rust was noted. Corrosion was found on the breakers. Breakers may not be functioning as designed due to rust.

12) Rust was noted. Corrosion was found on the breakers. Breakers may not be functioning as designed due to rust.

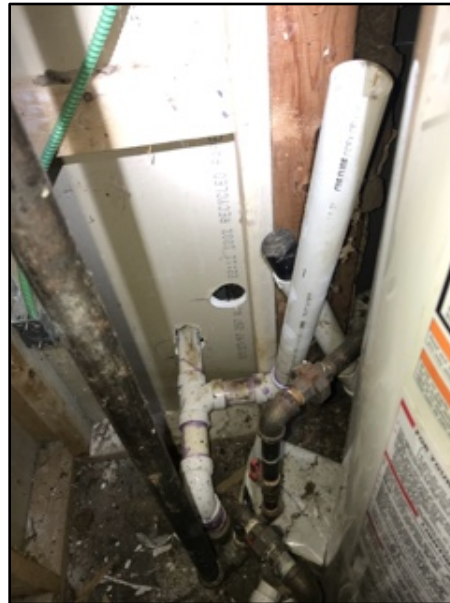
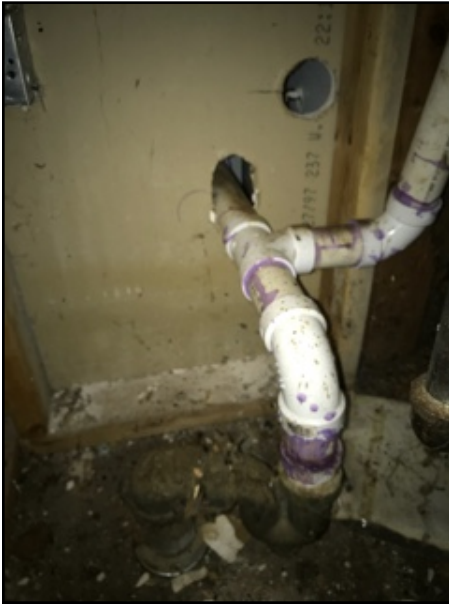
Areas of leaking or corrosion were found. Repair or replace as needed.

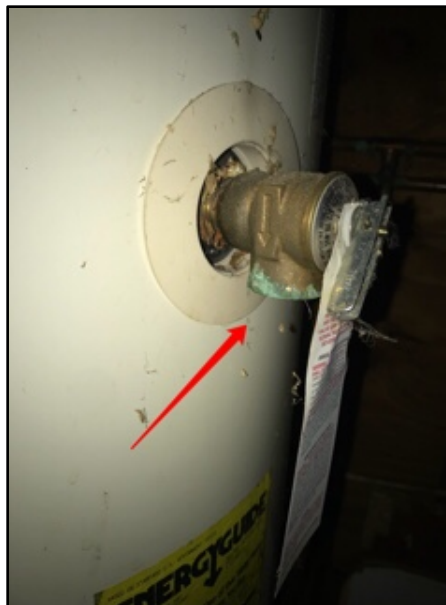
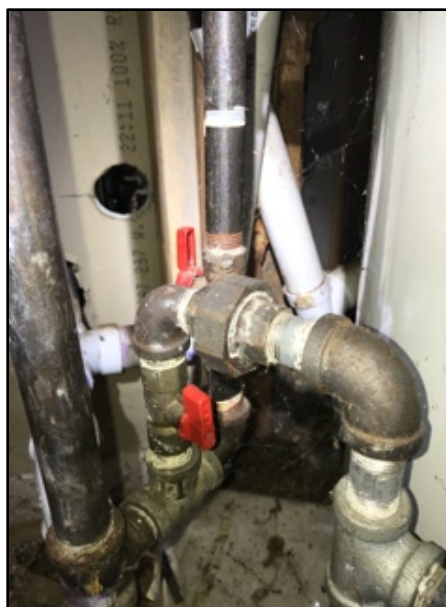
Unit appeared older. Average lifespan of water heaters is approximately 10 years. Unit may require replacement at any time. Recommend budgeting for replacement in the near future.

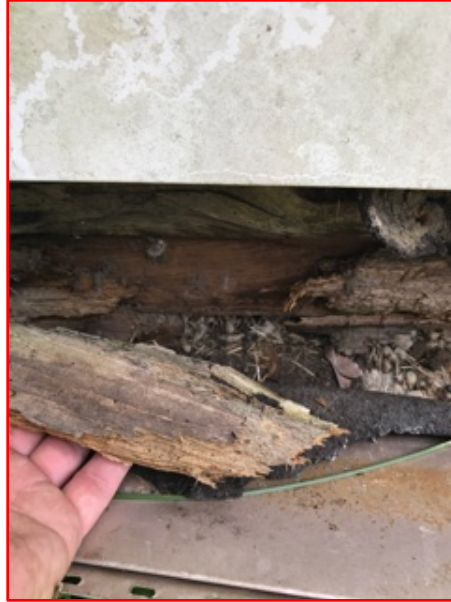
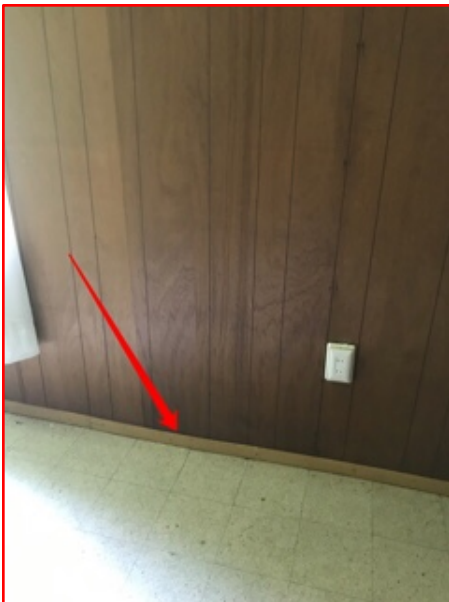
- 1) Open areas or damage was found. Repair or replace as needed.
- 2) AREA OF POSSIBLE MAJOR CONCERN - Moisture damage, wood rot, observed. Recommend review for repair by a contractor specific to this area pf expertise.

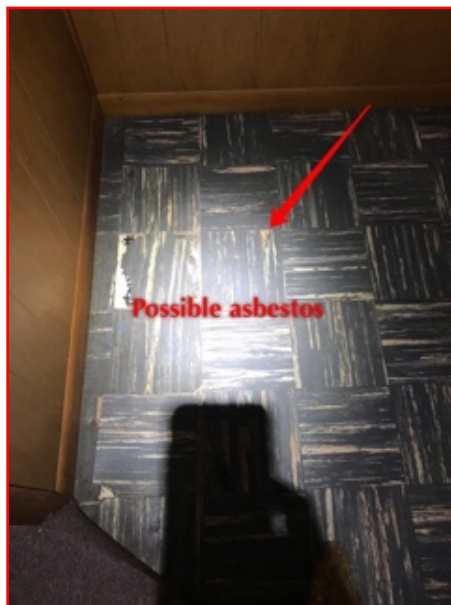
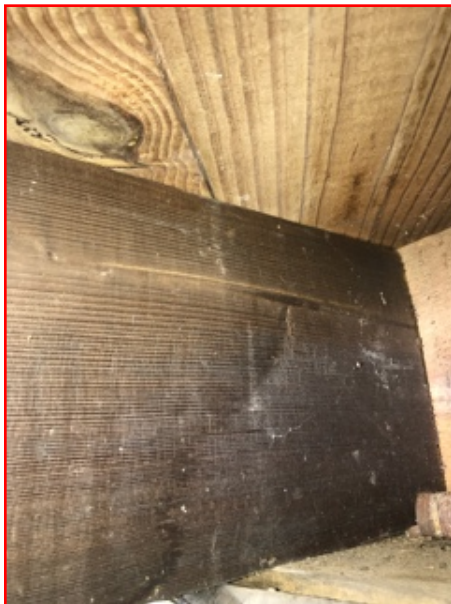
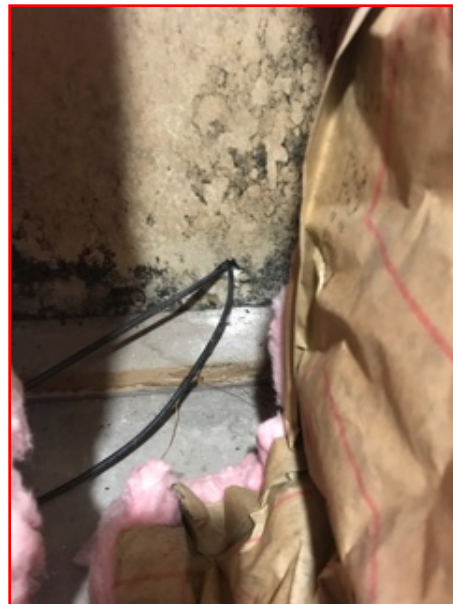
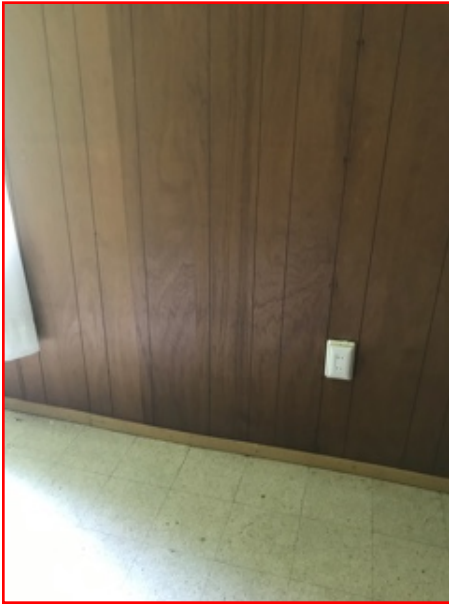
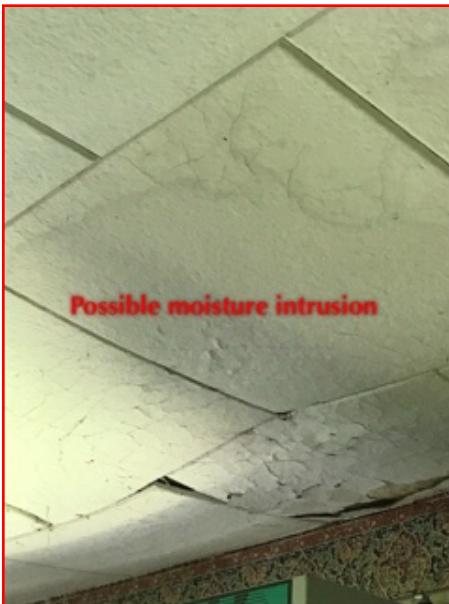
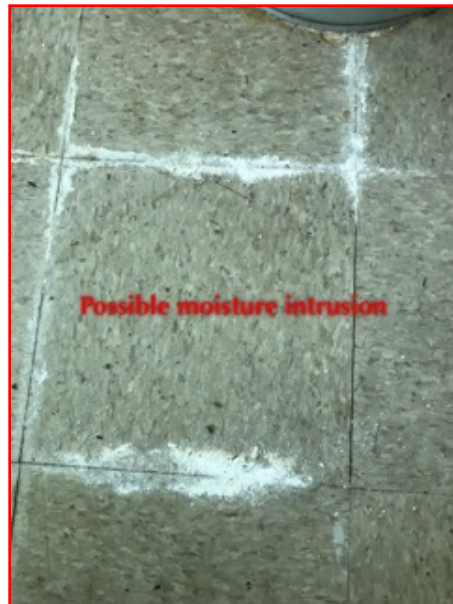
4) AREAS OF POSSIBLE MAJOR CONCERN WERE FOUND.

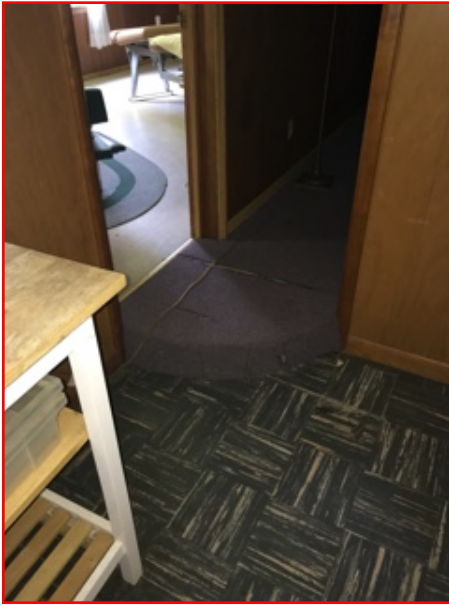
5) Possible asbestos found in the flooring of the home. Component may contain asbestos. Asbestos exposure has been linked to health problems and may merit further investigation. Positive confirmation can only be done by a licensed asbestos professional. Consultation with an asbestos professional may be desired prior to commitment.

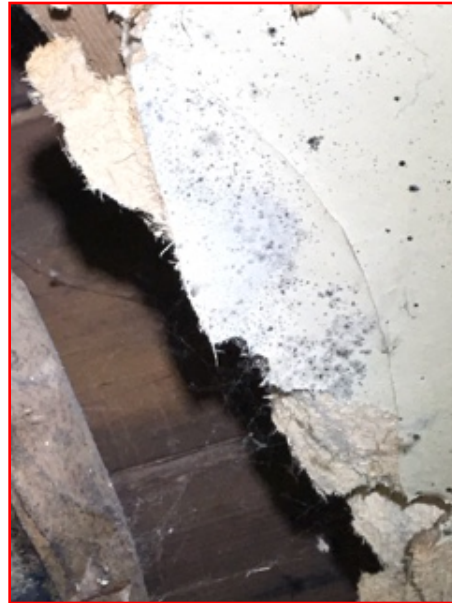
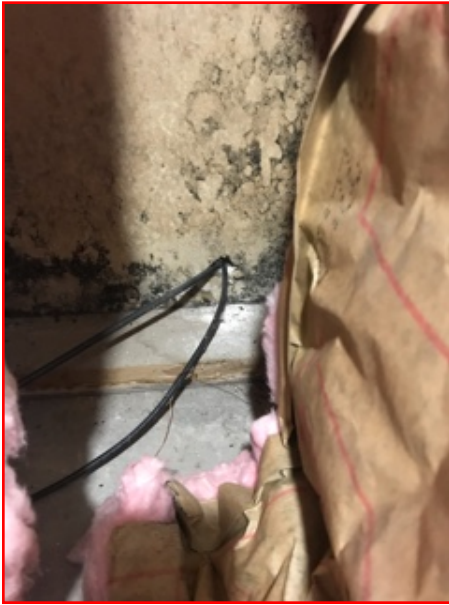
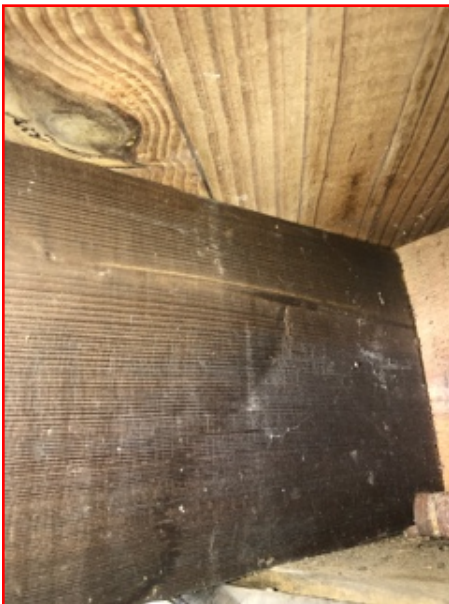
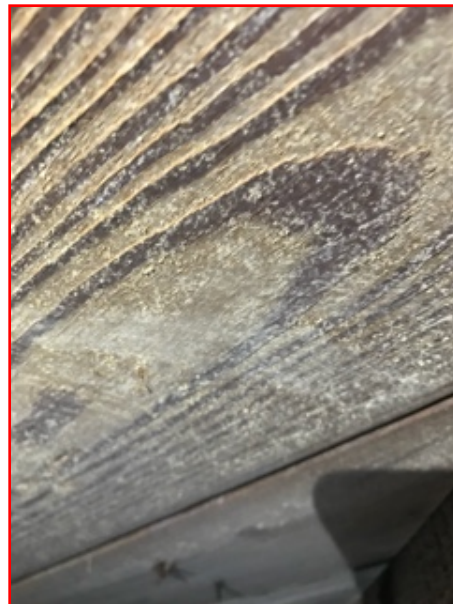
8) A suspicious discoloration or possible microbial growth was noted. Discoloration may indicate a larger issue adversely affecting the structure. Recommend a qualified specialist be contacted to evaluate the area and recommend corrective course. Additional areas of the house may require assessment at the discretion of the specialist.
